# Northwest Residential Inspection

Client: John Doe  
Address: xxxxx xx Ave. S.E., Sammamish, WA

Property Description: Tri-Level Single family home  
Property age/ size: Built 1979, 2025 s.f. per King Co. records  
Occupancy Status: Occupied

Inspection Date: 01/19/2010  
Inspection Time: 10:30 A.M. – 1:15 P.M.  
Weather Conditions: Cloudy, 53 deg F

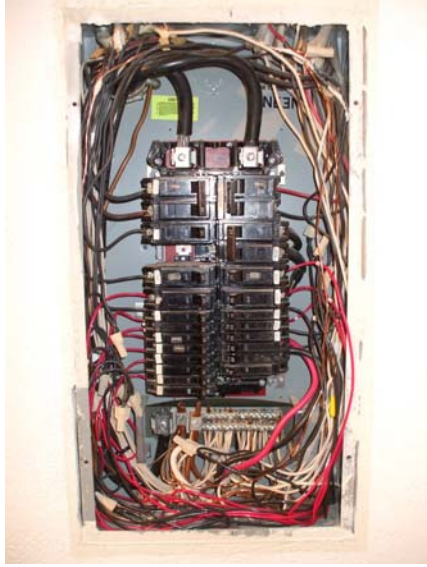
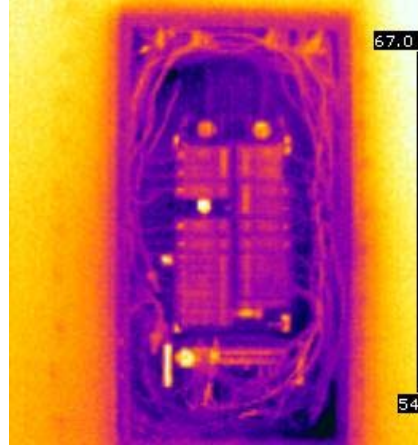
Infrared Image  
No evidence of over-heating

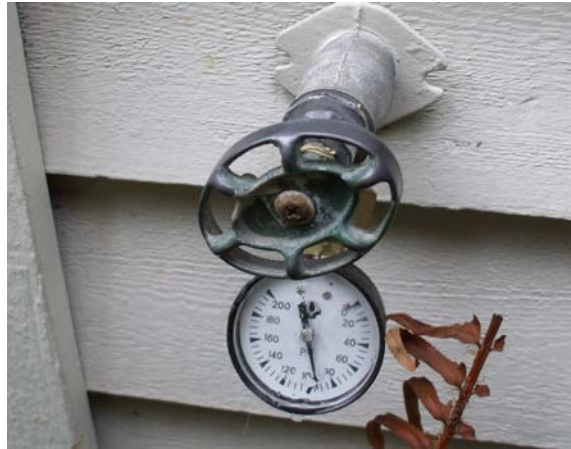
Supply: Public water  
Supply Pipe: Not visible  
House Piping: Copper where visible  
Pipe Condition: Satisfactory  
Main Water Shut off: Basement bath cabinet  
Water Pressure: 95 PSI @ hose bib  
- Water pressure exceeds recommended maximum pressure of 80 PSI

Water Pressure @ hose bib

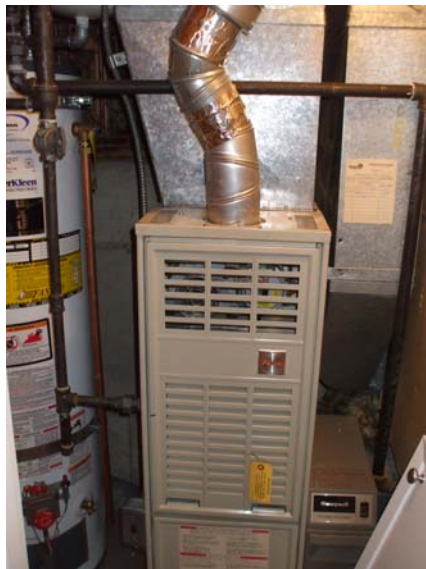
Est. Useful Life new: 25 years  
Est. age of furnace: 23 years, manufactured 11/87 per plate  
*- Furnace is fully functional, however near the end of its anticipated useful life*

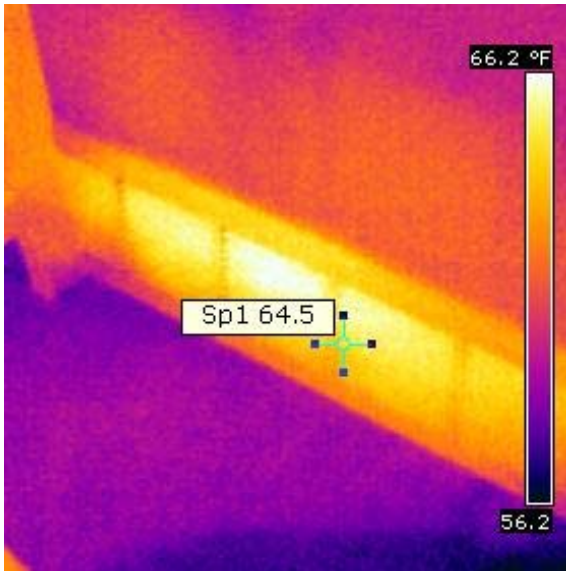
Rating: 40-70 deg F  
@ return air: 65 deg F  
@ nearest register: 115 deg F  
Heat Gain: 50 deg F

Temperature @ return air

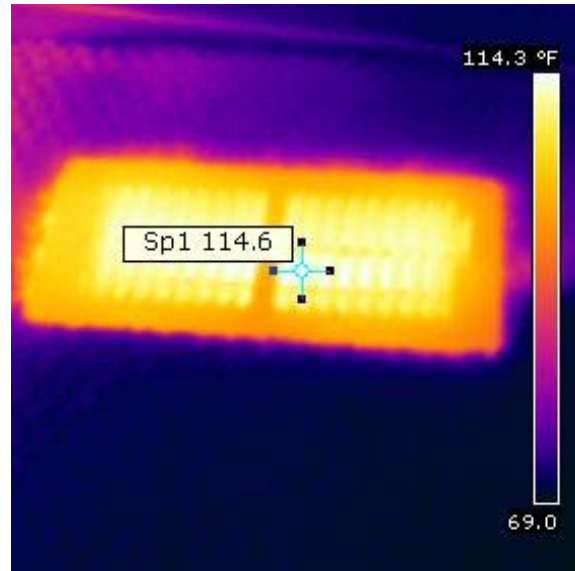
Temperature @ register

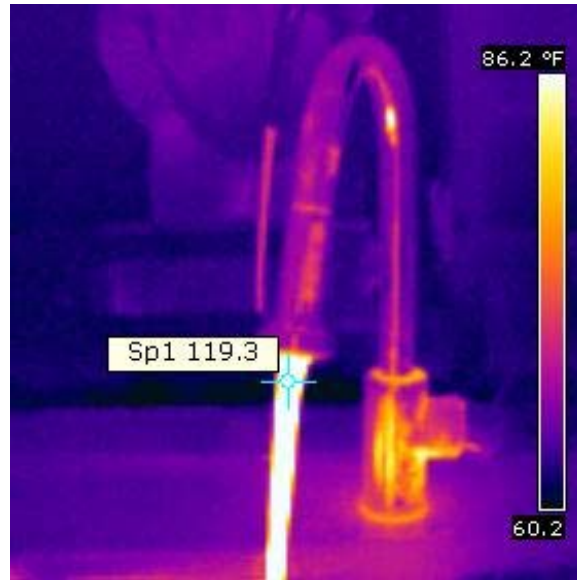
Safe water temperature: 120 deg F per industry standards  
Measured temperature: 119 deg F

Water temperature @ kitchen faucet

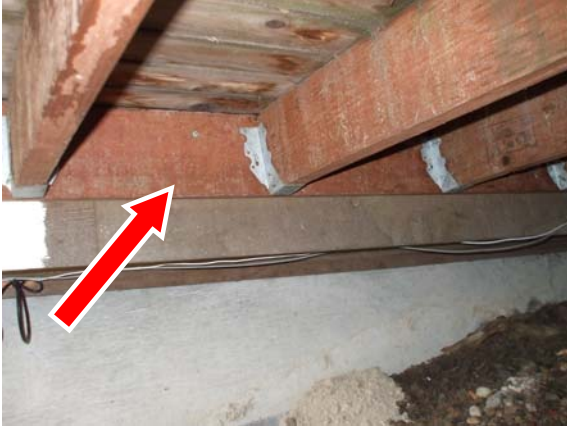
Structure: Pressure treated joists  
Decking: Cedar  
Condition: Satisfactory  
Connection to Structure: Toe nails  
**- Deck ledger not lag bolted to house. Potential separation from house**  
Trip Hazard: None  
Handrails: - Graspable handrail missing at both stairways from deck to ground  
Barricades: As required

Deck ledger toe nailed to house  
Potential separation of deck from house

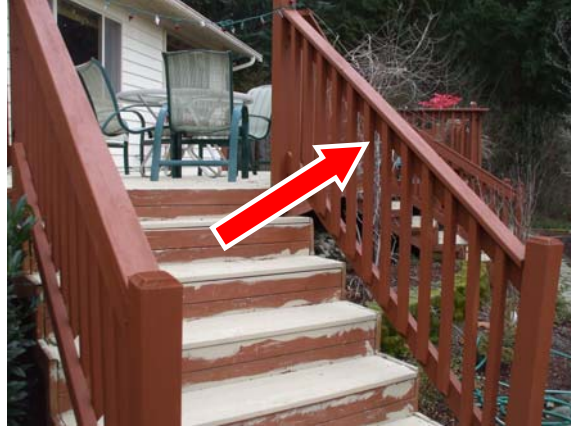
Graspable handrail missing at both stairways

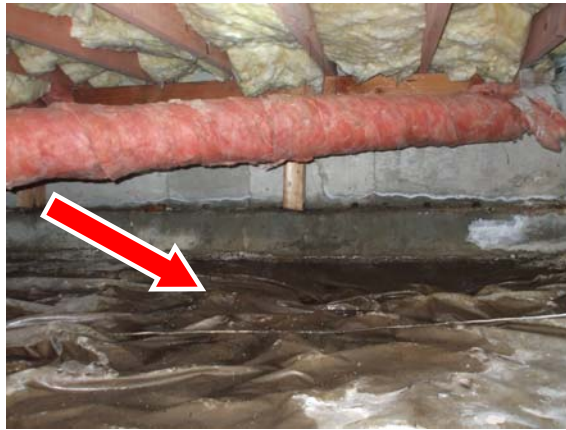
Ventilation: Appears adequate  
Vapor Barrier: As required  
Ground Water: No visible evidence  
Surface Water: - **Standing water under Living room (WDO Conductive condition)**  
Sump Pump: None visible

Standing water under Living room

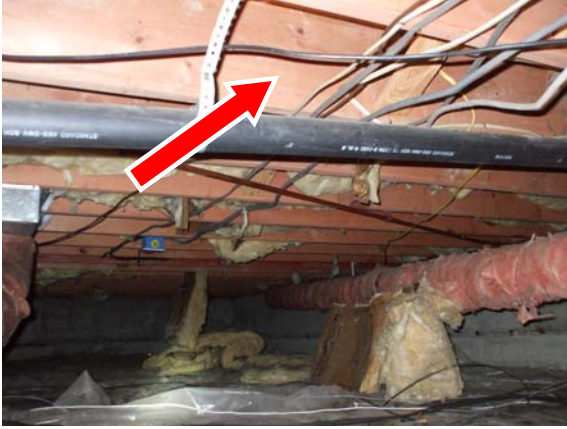
Under-floor: - Numerous areas with little or no insulation  
Domestic Water Pipes: - Domestic water supply pipes not insulated  
Heating Supply: Satisfactory

Missing under-floor insulation

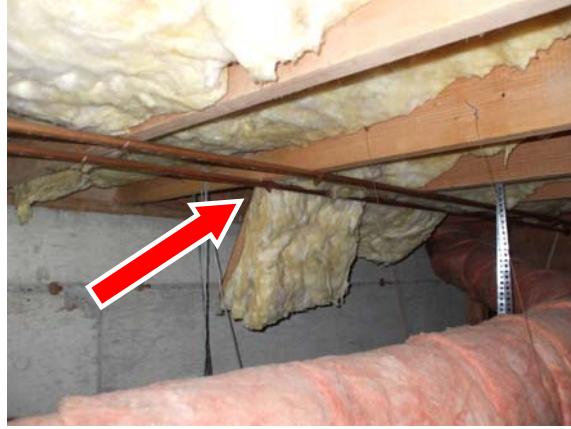
Un-insulated domestic water pipes

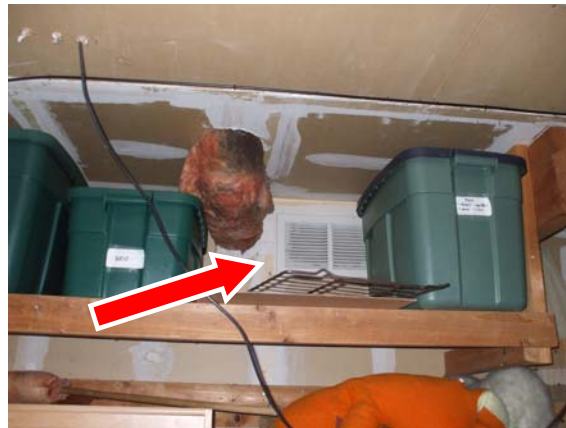
Fire separation: **- Fire separation breached by heat duct into garage**  
Ignition point > above FF: In compliance  
Safety barricade to mech.: N/A

Breach of fire separation of garage to house

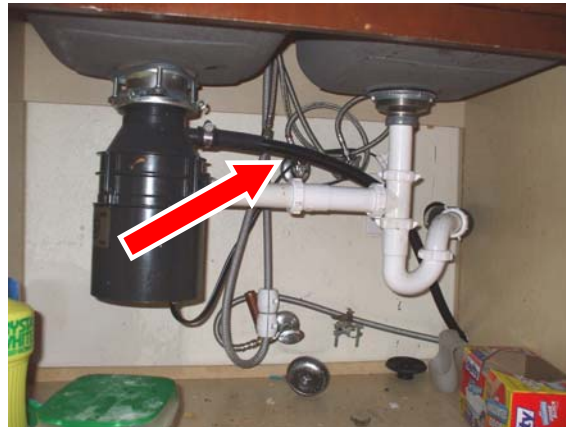
Functional flow: Appears adequate  
Hot/ Cold: Tested  
Drainage: Appears adequate  
Visible leaks: None visible  
Cross Connection: - Dishwasher drain does not have “high loop” or air-gap. Potential cross contamination  
Disposal: Tested  
Caulking: Satisfactory  
Fixtures: No visible defects

Potential cross contamination of sink drain water into dishwasher

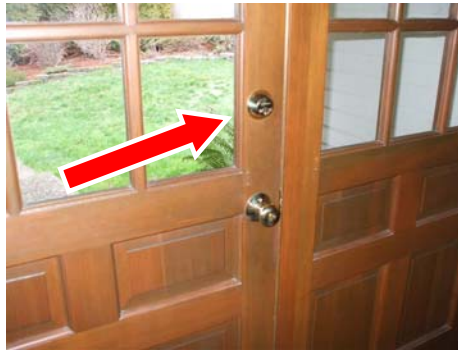
Operation/latching: - Double sided deadbolt at front door egress hazard in emergency  
Door condition: Satisfactory  
Millwork condition: Satisfactory

Double sided deadbolt at Front door. Key required for egress

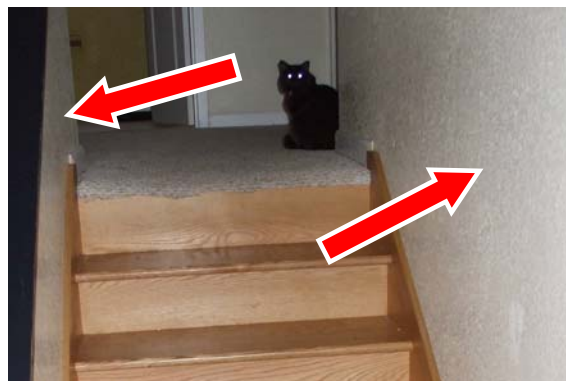
Handrails: - *Graspable handrail missing at upper stairway*  
Barricades: As required  
Balusters: As required  
Trip Hazard: None

Handrail missing

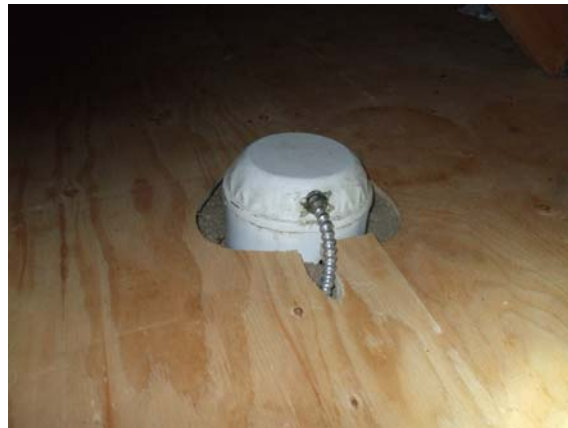
Outlets: None visible  
Wiring/ junction boxes: No visible defects  
*- Non IC rated recessed cans are buried in insulation. Potential fire hazard*

Recessed can buried in insulation and constrained by plywood
